UNITED STATES DEPARTMENT OF THE INTERIOR
NATIONAL PARK SERVICENATIONAL REGISTER OF HISTORIC PLACES
INVENTORY -- NOMINATION FORM

Martingham

Martingham
Talbot County
Maryland

INVENTORY FORM FOR STATE HISTORIC SITES SURVEY

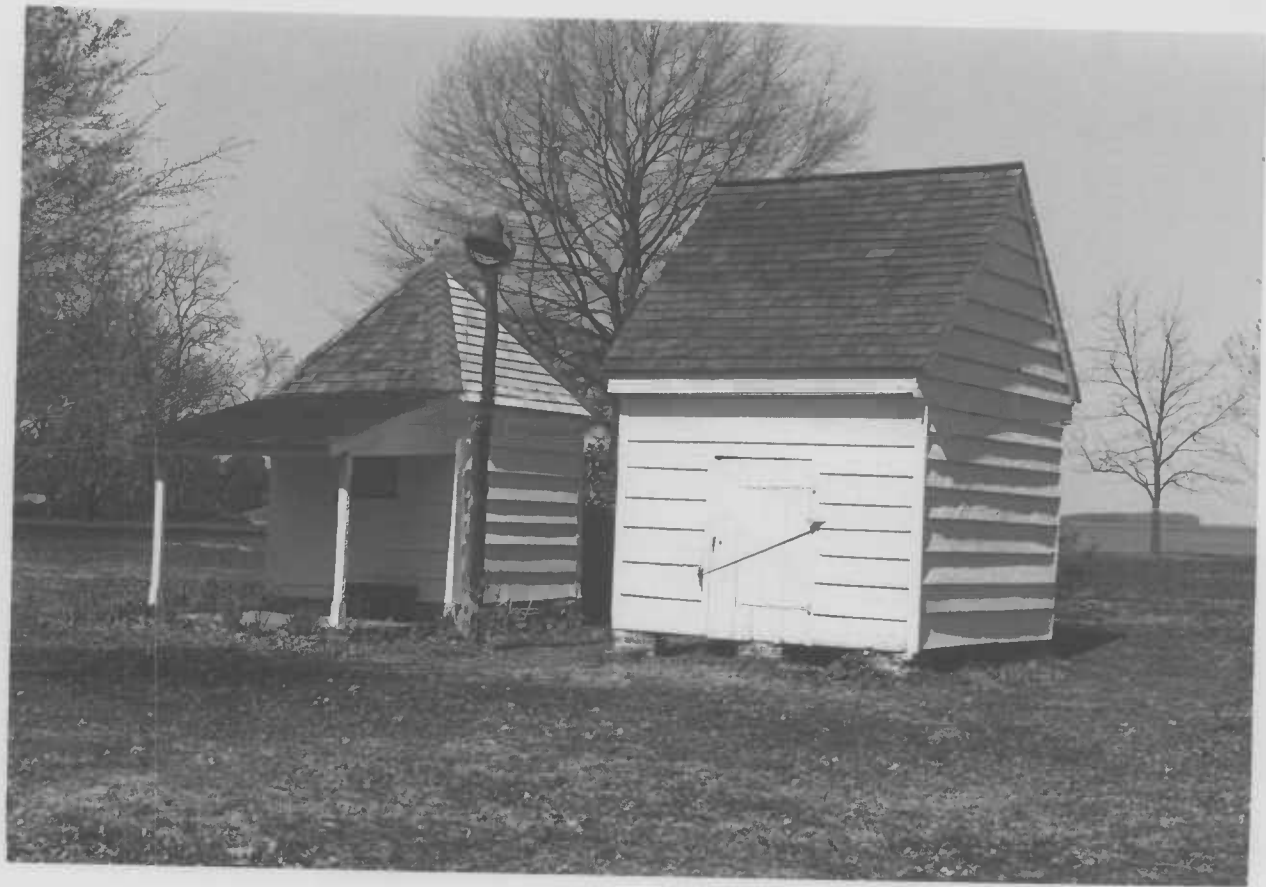
Martingham

North of the kitchen stand two early outbuildings--a dairy and a smokehouse. The dairy is a small, square building with pyramidal roof and a lean-to porch. The finial is very weathered. The original floor is below grade now, and there is a makeshift wood floor. The building stands on a brick foundation.

The smokehouse is a good framed structure covered with white pine weatherboard standing on brick piers. The batten door has strap hinges and a long iron bar for securing it. Besides the usual joist or tie beam is one set of collar beams. Several areas of the walls are sheathed.

outbldgs
